More sea cliffs collapse at West Coast mine

The coastal sea cliff overlooking West Coast beaches being mined by an Australian-owned company has collapsed in four more places. This follows the catastrophic 2015 collapse directly in front of the mine's processing infrastructure.

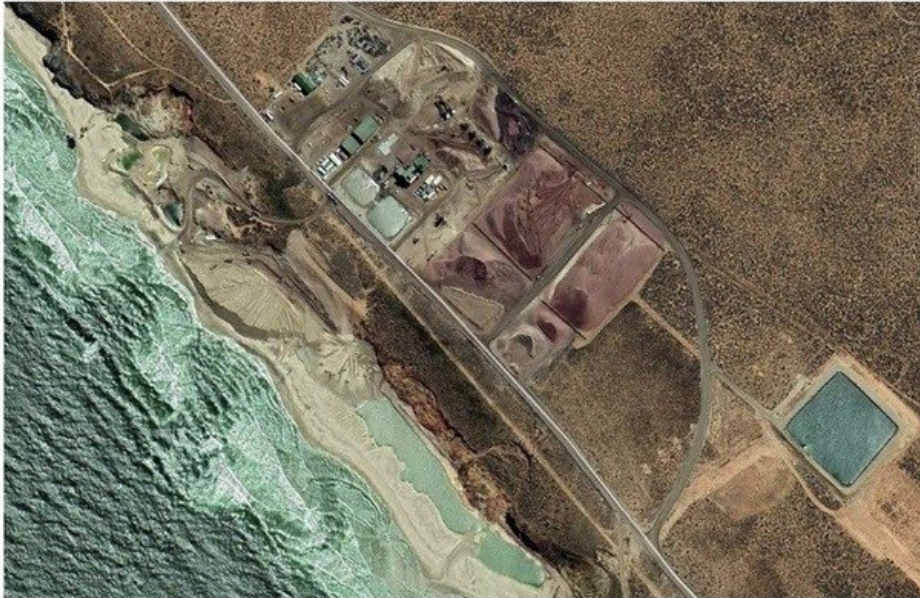
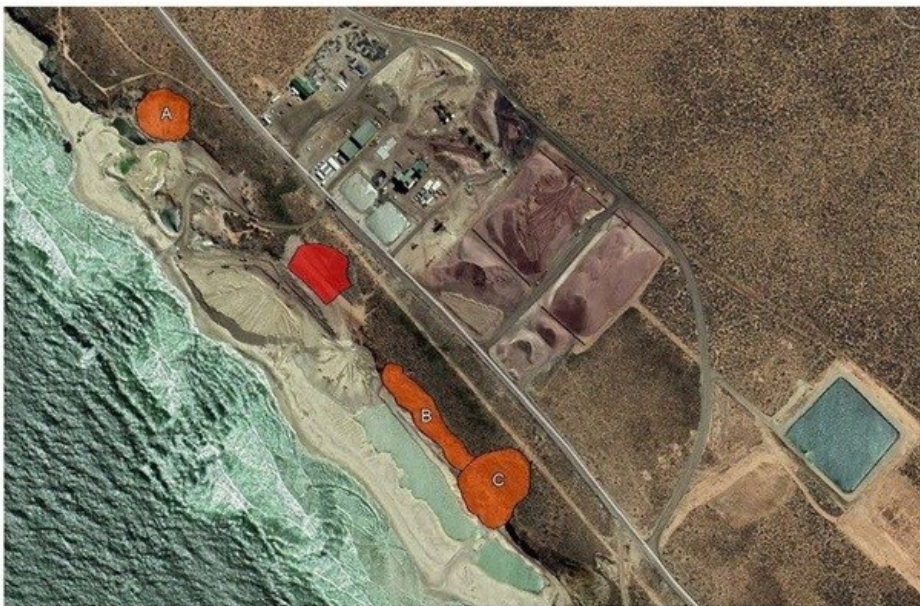
This Google Earth image, dated 15 March 2018, shows four collapses of the sea cliff in front of the Tormin mine processing plant. In the duplicate image below, the area of the 2015 collapse — where the mine has apparently attempted some rehabilitation — is shown in red, while three subsequent collapses are shown in orange. The fourth new collapse has occurred further to the south and is not visible in this image. Photo: Supplied by Allen Lyons

“From my satellite image interpretation it appears that there have been four other cliff failures since the original collapse of 2015, and most of the new collapses are as big or bigger than the 2015 collapse,” said Lyons. “My preliminary findings indicate that the new collapses are occurring in areas where the beach has been mined more than once and where mining benches have advanced to within ten metres of the toe of the cliff.” (A mining bench is a narrow strip of land cut into the side of an open-pit mine.)

Lyons said it appears that Tormin has attempted to rehabilitate the 2015 collapsed area with sand tailings from the mine’s processing plant. He estimates that between 500,000 and 600,000 tonnes of sand has been borrowed from other beaches to “prop up” the 2015 collapse.
