# Zutari's duckbill design put to the test at Garden Route Dam

Zutari's spillway project at the Garden Route Dam was finally put to the test late last month when it began spilling following torrential rains in the area. The dam is the main supply for George in the Western Cape.

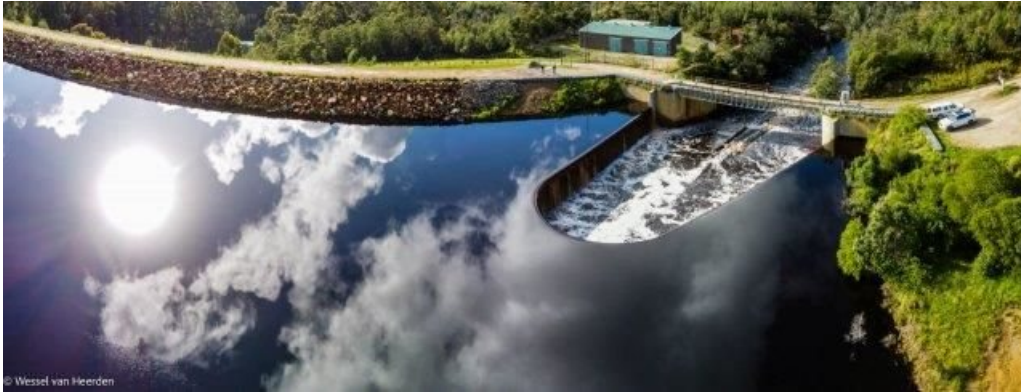
Zutari designed the duckbill-shaped spillway to slow down water flow using basic physics principles. Image: Wessel van Heerden

The project increased the existing storage capacity of the Garden Route Dam by raising its full supply level by 2.5m via the installation of a new spillway, enlarging the storage volume by 2.5 million cubic metres. The solution centred on a hydraulic design in the form of a non-linear spillway in the shape of a duckbill. Although duckbill or bathtub spillways are not unique, they are rare worldwide.

The Zutari team amended the hydraulic design to ensure that the weir would behave in a safe and predictable manner. The shape of the duckbill causes flow on opposite ends of the overflow flow to collide within the duckbill, causing an upwelling, also known as flow bulking, which breaks the flow's momentum and causes it to lose its energy. The flow from the rounded upstream end of the spillway is not so opposed and causes this upwelling of flow to move toward the exit of the spillway at rapid velocity. This increase in velocity reduces the water level to a lower elevation such that it can safely pass under the bridge over the spillway.

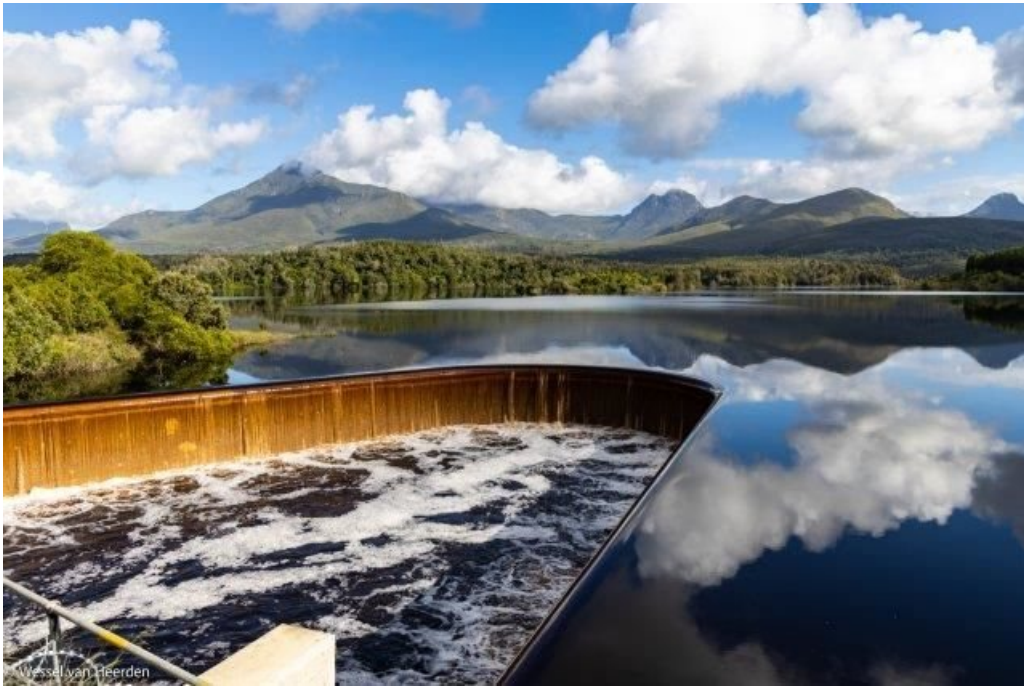
The new spillway overflowed on 22 November 2021. Image: Wessel van Heerden

The final duckbill spillway design resulted in a total spillway length of 80m, with a maximum discharge capacity of 570m<sup>3</sup>/s at a freeboard of 4.1m. The flood event on 22 November was the first time the new spillway overflowed since its completion in December 2019. Prior to the flood event, the water level in the dam was roughly 1m below the crest of the spillway. This volume was rapidly filled up in the course of the early morning and the spillway started overflowing at roughly 8.30am. The peak of the flood occurred at 1pm, according to the Department of Water and Sanitation's water level-data record.

The water level recorder logged a maximum overflow depth of 0.509m over the crest, which equates to about 50m<sup>3</sup>/s in discharge. This thus appears to have been a relatively minor event, with the dam designed to cater for much higher flows. That said, the incoming flood was partially attenuated or absorbed by the storage volume in the dam basin. The flows at the nearby flow logger on the Malgas River likewise recorded a minor flood.
