Silo collapse results in load shedding across SA

3 Nov 2014

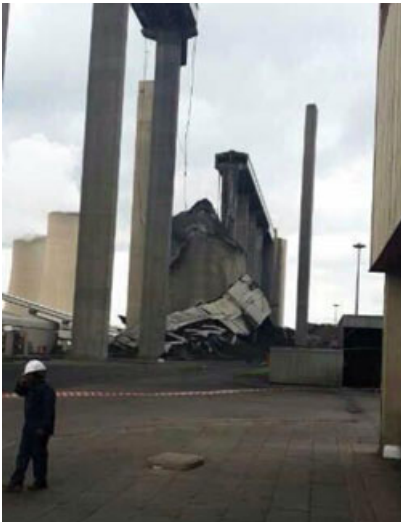
This after one of the three silos, which housed over 10,000t of coal each, cracked and later collapsed at Majuba power station on Saturday, impacting coal supplies to six units.

The collapsed silo. (Image: Eskom)

He said all units were running normally yesterday, prior to the silo collapse, but at approximately 12:30, one of the staff members at the station reported a visible crack on silo number 20.

He said the crack on the silo enabled personnel on the station site to be evacuated. The crack was later followed by a collapse.

Matona said Eskom engineers are investigating the cause of the incident and results will be communicated in due cause.

"The latest civil-visual inspection that was conducted in September 2013 found that the concrete structure was in good condition," he said.

He added that there was some external damage which was attended to and that risk classification at the time was classified as low.

Eskom said it would in the meantime make use of mobile coal feeders at the station, as one of interventions to recover lost capacity.
