# Drakenstein achieves significant water loss reduction after installing HDPE pipes

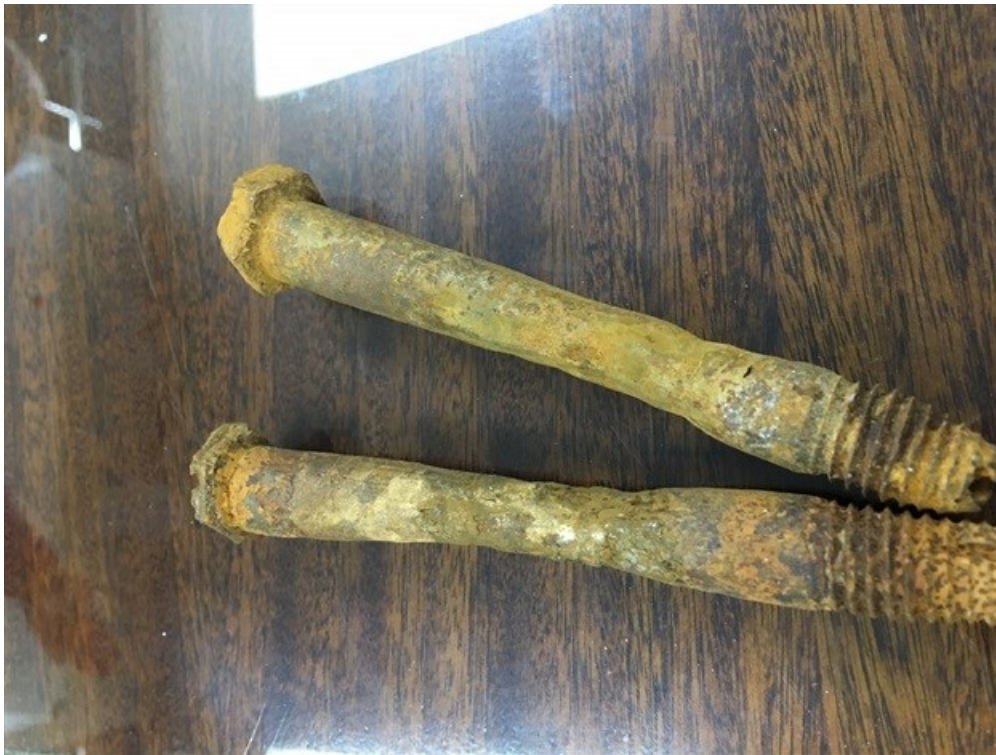
Steel screws show corrosion

He adds that the most attractive advantage of HDPE is a pipe system without pipe joints. “We no longer have the issue of corrosion, failing joints or costly maintenance issues due to downtime, as most of the fittings used in HDPE systems are moulded out of polyethylene material.
