## Drakenstein achieves significant water loss reduction after installing HDPE pipes

### Replacing aging pipes with HDPE pipes

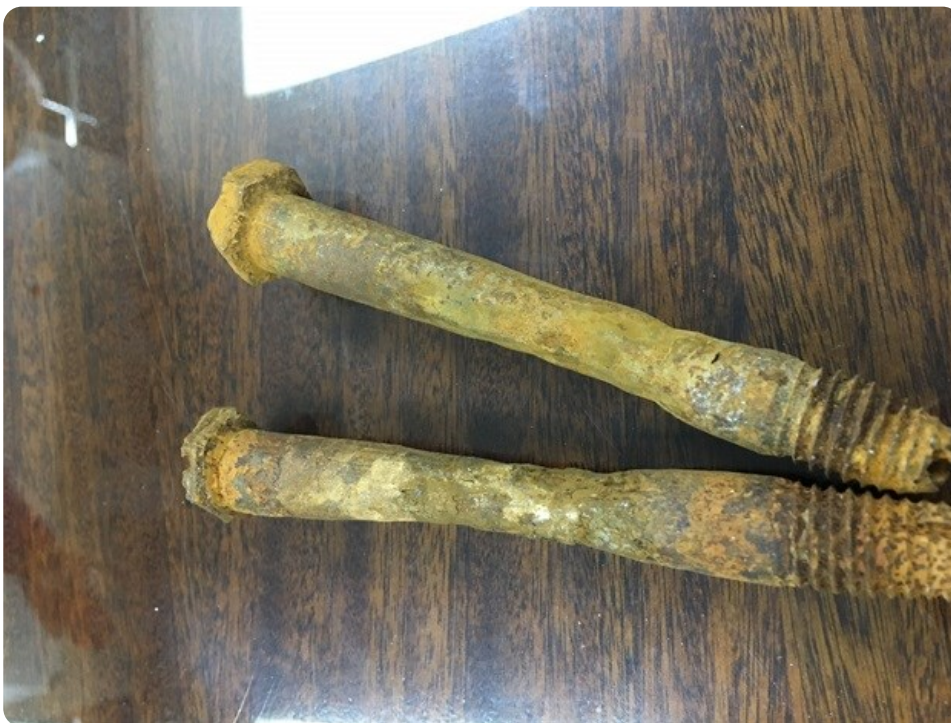
Steel screws show corrosion

He adds that the most attractive advantage of HDPE is a pipe system without pipe joints. “We no longer have the issue of corrosion, failing joints or costly maintenance issues due to downtime, as most of the fittings used in HDPE systems are moulded out of polyethylene material.
